Post Traumatic fracture of Shaft of femur with avulsion fracture of ipsilateral lateral epicondyle of femur and avulsion fracture of tibial spine and ipsilateral Posterior cruciate and Lateral collateral ligament injury without distal neurovascular deficit: A Case Report

Type of Publication: Case Report

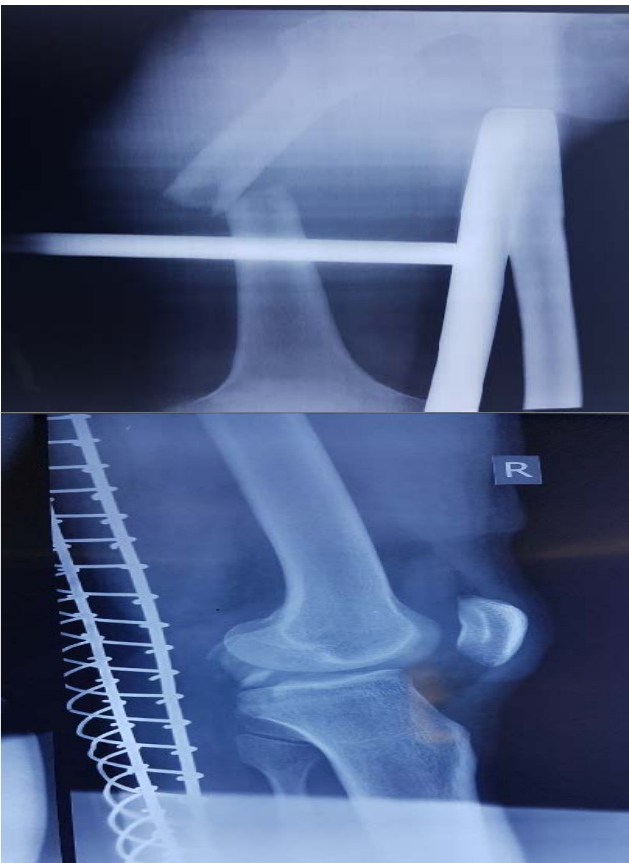
Figure: 2 Xray AP and Lateral view of Right Hip with Thigh showing fracture of shaft of femur with avulsion fracture of lateral condyle of right femur.

Patient was initially managed with upper tibial traction and immobilisation on modified bohler-braun splint after getting all appropriate x-ray views (as shown in figure 2,3). On day two, we noticed a posterior sagging of right

So in conclusion we advise that it is more imperative to have all x-rays that is one joint above and below the fracture (in our case, fracture femur shaft) and to have atleast two views perpendicular to each other as in this case AP view of knee did not show avulsion fracture of lateral epicondyle and could have been missed and to have suspicion of single/multiple ligamentous injuries in presence of even avulsion fractures around the knee and a small avulsion fracture around the knee joint should not be dismissed but instead be addressed carefully, as it may indicate the presence of a major ligamentous injury.

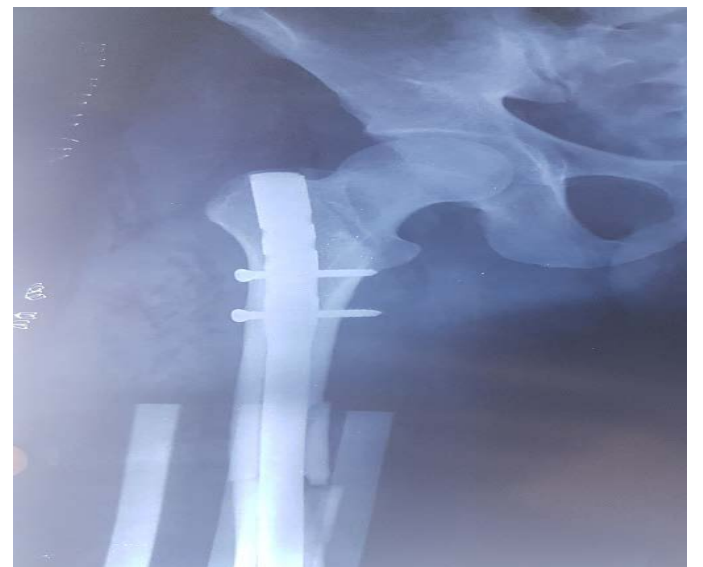
Figure: 4 post operative xray after fixation of fracture shaft of femur with intramedullary nailing

Patient was planned to be operated in one sitting, Closed interlocking of femur following which open reduction and internal fixation of lateral epicondyle of femur done with one cannulated cancellous screw and then Arthroscopic PCL repair using fiber thread was done. During knee arthroscopy tourniquet was not used.

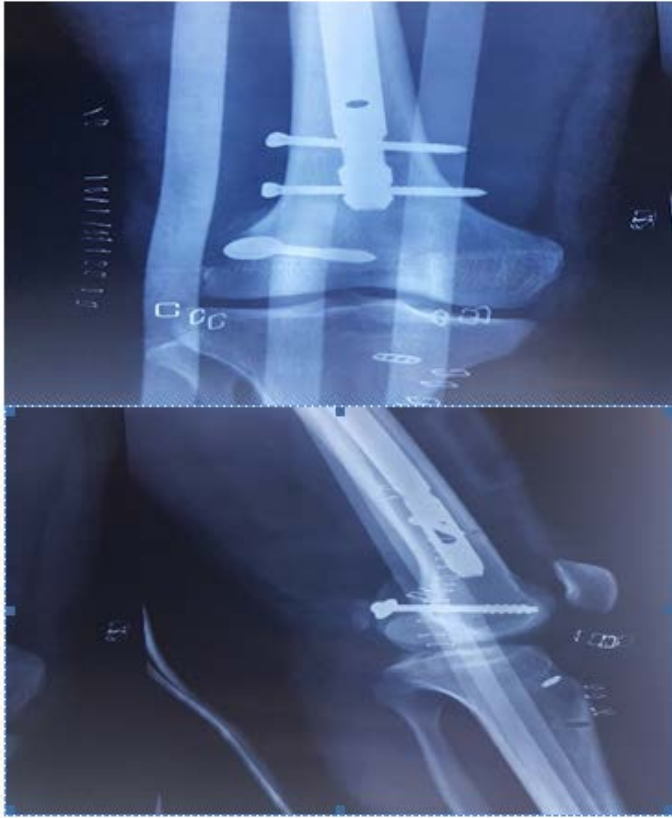
Figure: 5 post operative xray after fixation of fracture lateral condyle with cannulated cancellous screw.
